# Office floor vibrations: modal parameter identification and vibration monitoring

**ABSTRACT:** Several people working on the 2nd floor of an office building complained about disturbing floor vibrations. The building consists of five floors. In the contrary to the other floors, the 2nd floor slab has no floor-to-ceiling secondary walls neither beneath nor on top of the slab. The modal parameters of four floors were identified using ambient vibration testing (AVT)-technology and a 5-kg-medical ball as a vibration generator. The fundamental natural frequencies of the floors were: 2nd: 7.4 Hz, 1st, 3rd and 4th: 11.5...12 Hz. To monitor the vibration intensity and to identify the source of the vibrations, a triaxial velocity sensor was subsequently mounted in a critical point of the 2nd floor slab. The vibrations were monitored for two months using a newly developed internet-accelerograph. This allowed on-line checking of the vibrations and downloading of the data on an external server on a daily basis. Processing of these data yielded that no other source of the vibrations could be identified than people walking on the floor. Rating of the measured vibrations according to ISO 2631 y

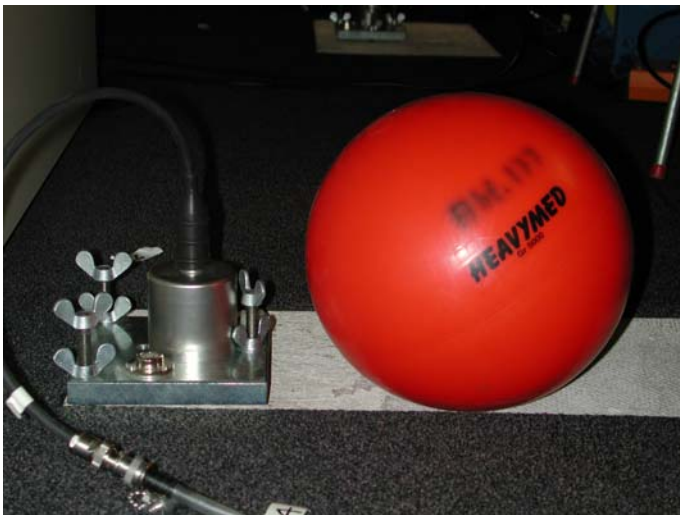
Figure 4: The medical ball used to excite the slabs and one of the accelerometers used to measure the slab response.

To identify the dynamic parameters of such a structure, experience has shown that it is a good idea to artificially increase the level of structural vibrations during the "AVT" investigation. Moving on the floor and dropping a 5 kg medical ball from a height of roughly 1 m at irregular intervals of one to four seconds has proven to be a very efficient means of excitation for concrete floors exhibiting dimensions of several meters (Fig. 4).

Piezo-electric sensors PCB 393B31 with a sensitivity of 10 V/g were used to measure the floor vibrations (Fig. 4). The measurement point grid consisted of three vertical reference points and 35 roving vertical measurement points. The latter were covered with five roving sensors in seven setups.

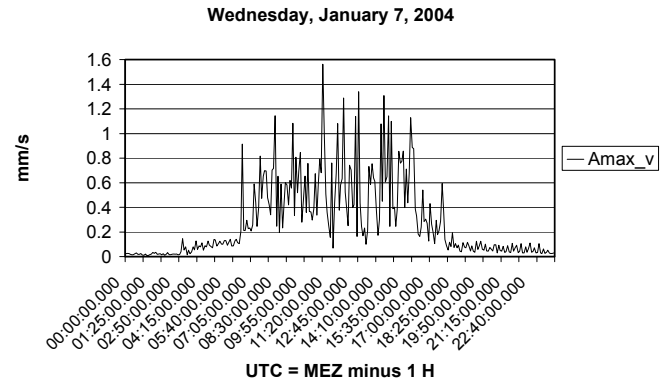
Figure 12. Floor vibrations for a typical normal working day.

Figures 12 to 15 show the peak values of all 288 5-minute-time windows of the vectorial velocity as a function of time for a 24-hours monitoring time. Diagrams of this type were calculated on a daily basis and were used to get a first insight into the behaviour of the floor under investigation. The behaviour as shown in the Figures 12 to 14 can be called

"typical" and covers almost all of the 64 days of undisturbed 24-hours monitoring. These "typical" diagrams, identically scaled on the ordinate, include a normal working day (Fig. 12), a typical Sunday (Fig. 13) and a typical Saturday (Fig. 14).

Many people walking on the floor resulted in maximum vectorial velocity amplitude values in the range  $a_{\max}v = 0.8 \dots 2.5$  mm/s (1.34 mm/s on the average).

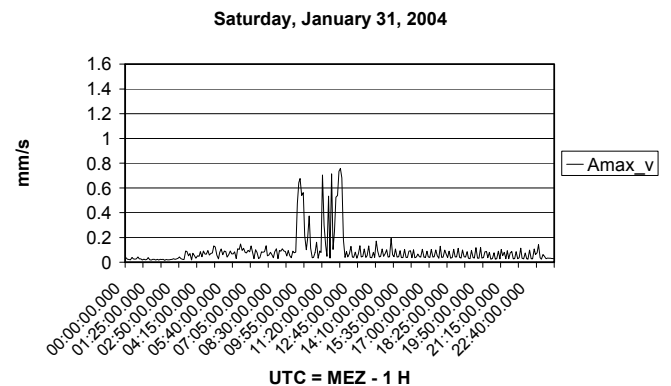
Figure 14. Floor vibrations for a typical Saturday.

Some people walking on the floor (typical Saturdays, one or two people present, mainly the room cleaning team) resulted in  $a_{\max}v = 0.4 \dots 2.0$  mm/s (0.94 mm/s on the average).

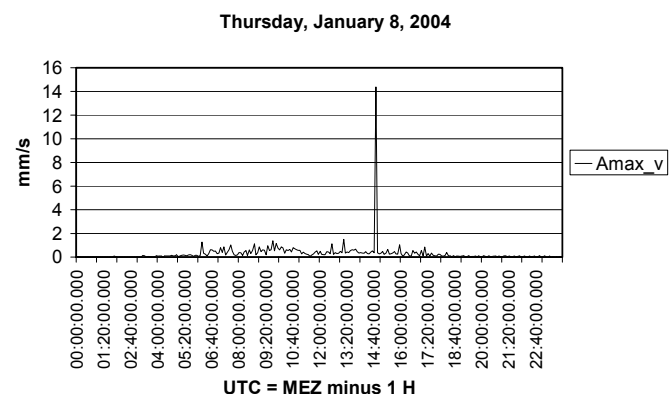
Figure 15. Normal working day with a singular event.

Figure 15 shows the diagram for a normal working day with one singular event. It was not possible to identify the source of this singular event. Probably, somebody "stumbled" over the velocity sensor.

An additional test was performed with making one person jump for two minutes in the neighbourhood of the velocity sensor. This yielded a peak value  $a_{\max}v = 6.2$  mm/s or roughly three times the value of normal walking on the floor and definitely less than what was measured for the "singular" event mentioned above.

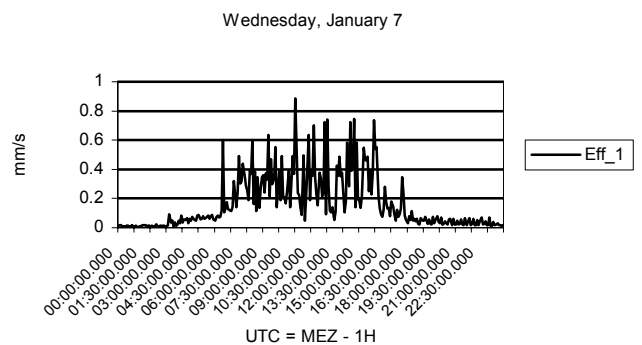
Figure 16. Floor vibrations for a typical normal working day.

The measured vibrations were therefore rated according to ISO 2631-1 (1997) and ISO 2631-2 (1989). This rating is based on measured RMS-values of acceleration or velocity. Processing the signals using the GeoDAS software package allowed to plot similar graphics as shown in the Figures 12 to 15 for RMS- instead of peak values (Fig. 16).

- normal working day:  $v_{\text{RMS}} = 0.47 \dots 1.45$  mm/s, 0.8 mm/s on the average,
- nobody present:  $v_{\text{RMS}} = 0.07 \dots 0.17$  mm/s, 0.11 mm/s on the average.

In summary: During working hours, the vibration level is up to 3.6 times higher than "satisfactory" according to ISO 2631. The vibration level valid for the state "nobody present in the building" is well below the "satisfactory" level according to ISO 2631.

At the moment, discussions are ongoing to find an optimum solution for the problem.

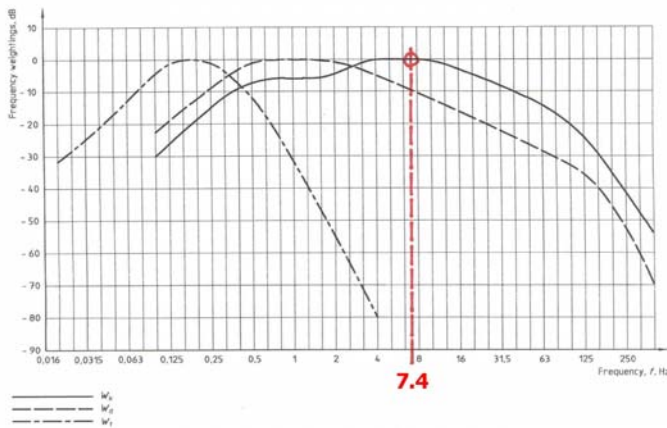
Figure 17. Frequency weighting curves as given in ISO 2631-1 (1997).  $W_k$  (solid line) applies for vertical movement.

The frequency weighting curves take care of the fact that the sensibility of humans against vibrations depends on the vibrations' direction and frequency. For vertical vibrations with a dominant frequency  $f = 7.4$  Hz, the frequency weighting is 0 dB.
